DEVELOPMENT OF A MODIFIED AIDS TO NAVIGATION
MANAGEMENT INFORMATION SYSTEM FOR THE
UNITED STATES COAST GUARD WITH AN
ILLUSTRATED APPLICATION THROUGH COST-
EFFECTIVENESS AND MALFUNCTION ANALYSES

THESIS

March 1975

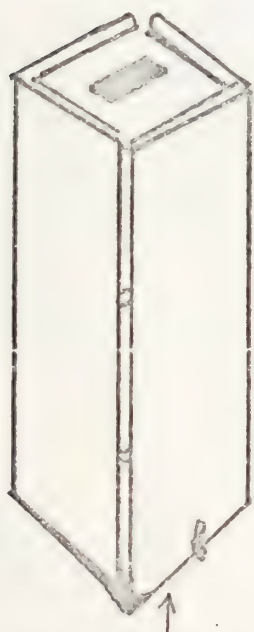
FIGURE 2

Power Assembly Clamp

Battery Pack

lighted buoy. The description of a typical lighted buoy equipped with standard components is presented in Figures 1, 2, and 3 and corresponding Tables II and III. An explanation of each component's function and general terminology are included.
